PIPE REHABILITATION

Restoring a corroded sewer

Robert Kelly & James Smolik describe the use of CCCP techniques to renew a concrete sewer that had suffered extensive hydrogen sulphide corrosion

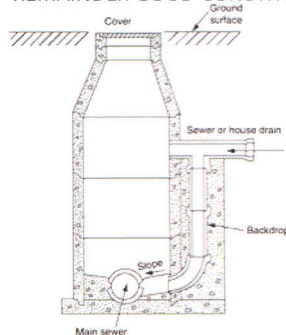
- **HYDROGEN SULFIDE CORROSION WAS SEEN AT ALL MAJOR TRUNK LINES (6) DUE TO DROP MANHOLES**

- 50' +/- MANHOLE
- REMAINDER GOOD CONDITION

Typical manhole (left) with typical effects of corrosion (right)

From the condition assessment in 2008, the greatest area of concern was microbiologically induced corrosion from hydrogen sulphide, which was prevalent throughout the entire system and concentrated at critical locations. These were at the connection points of the various trunk lines (458-610mm diameter) discharging into the sanitary interceptor.

At those connection points, drop manholes were located with at least a 3m vertical difference between the inverts of both pipes. Also, the downstream section of the interceptor had a large concentration of corrosion due to the proximity of the wastewater-treatment plant.

Vertical-drop manholes of trunk lines cause severe turbulence in the interceptor, releasing large amounts of hydrogen sulphide gas, produced from anaerobic bacteria in the sewage. Over time, the effects of carbon dioxide and hydrogen sulphide lower the concrete pipe's surface pH to below seven, thereby providing an ideal environment for *Thiobacillus*
