# Restoring a corroded sewer

Robert Kelly & James Smolik describe the use of CCCC techniques to renew a concrete sewer that had suffered extensive hydrogen sulphide corrosion

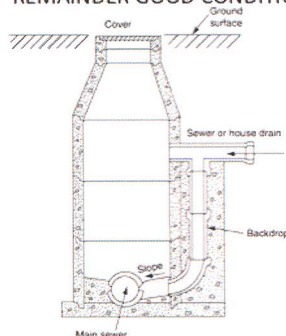
- HYDROGEN SULFIDE CORROSION WAS SEEN AT ALL MAJOR TRUNK LINES (6) DUE TO DROP MANHOLES

- 50' +/- MANHOLE
- REMAINDER GOOD CONDITION

*Typical manhole (left) with typical effects of corrosion (right)*

At the majority of locations, corrosion from sulphuric acid was confined to within 7.5-15m either side of the manhole, with the remainder of the interceptor in good condition. This concentration resulted from trunk lines with drop connections.

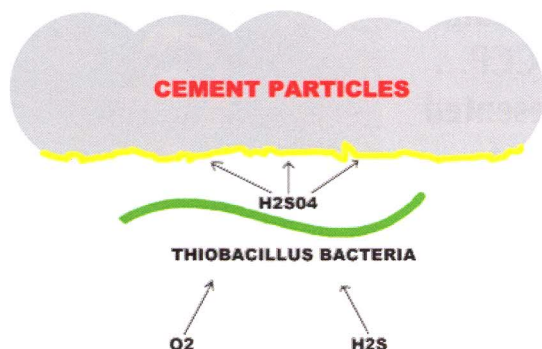
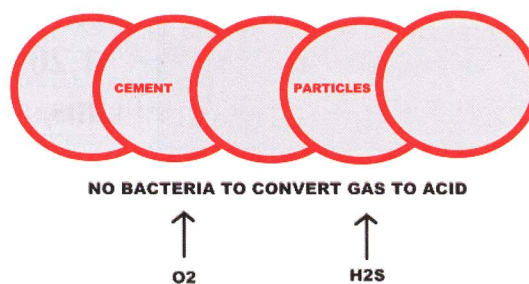
Vertical-drop manholes of trunk lines cause severe turbulence in the interceptor, releasing large amounts of hydrogen sulphide gas, produced from anaerobic bacteria in the sewage. Over time, the effects of carbon dioxide and hydrogen sulphide lower the concrete pipe's surface pH to below seven, thereby providing an ideal environment for *Thiobacillus*

Left: corrosion process  
Right: barrier protection

In the presence of oxygen, hydrogen sulphide gas reacts with the Thiobacillus bacteria in this region of the pipe, converting it into sulphuric acid through an aerobic-biological process. Sulphuric acid then attacks the concrete pipe, which can lead to structural failure.

Anti-microbial agents hinder the Thiobacillus bacterial growth on the interior surface of the pipe. This prevents the aerobic-biological process of hydrogen sulphide gas converting to sulphuric acid. The high compressive strength of the cementitious coating also improves the ring compression of the pipe.

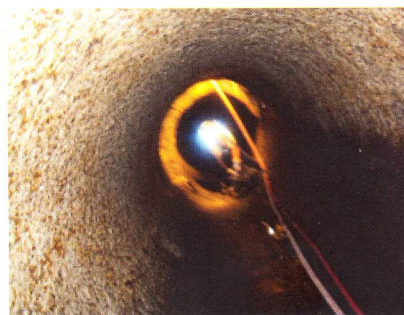
Operator controls Spincaster application rate

The CCCP coating was applied as a 12mm-thick layer on the surface of the prepared pipe by a

spin-caster; this was pulled through at a uniform rate using compressed air to apply the pumped, cementitious coating around the circumference of the pipe.

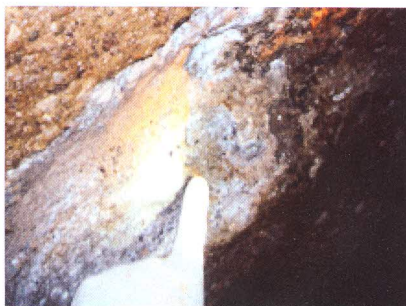
Organic matter and deteriorated pipe

Once a bypass was established, the sewer pipe was prepared for rehabilitation. Man entry was undertaken with compressed air and high-pressure water to clean the pipe of any organic matter and/or deteriorated pipe fragments. Compressed air was also used to dry →
