## **St. Louis MSD Maline Drop Shaft Long Term Testing**

1. Situation Background
2. 1999: Structural Restoration
3. 2009: Ten-year Inspection
4. Implementation into St. Louis MSD Specifications
5. 2015: Sixteen-year Inspection
6. Third-party test reports
  - a. Microbac, 3 pages, August 2010
  - b. Situ Biosciences, 3 pages, January 2011

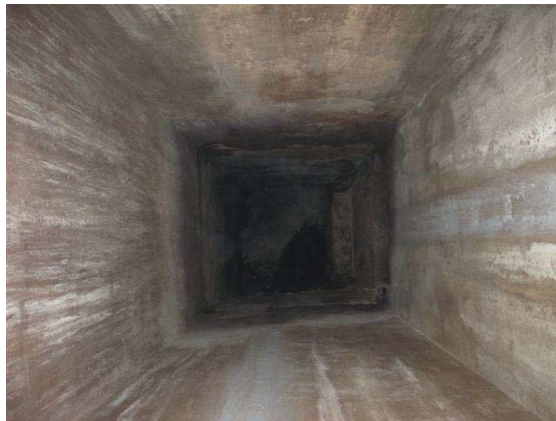
*Figure 5 Photo of the shaft looking down during the 2009 inspection*

In 2009, MSD conducted a 10-year inspection of the pilot restoration program of the Maline Drop Shaft. The inspectors concluded the restoration project successfully protected the structure from MIC and added Con<sup>mic</sup>Shield® to the approved specification for structural construction projects in the District.

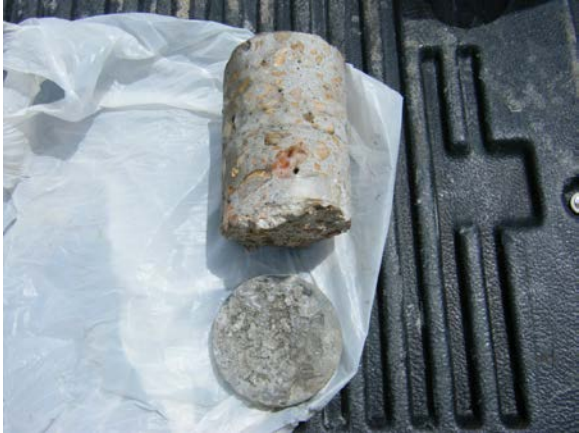
*Figure 7 Photo of the core sample*

The photo of the core sample in Figure 7 shows two pieces. The large piece was labeled Maaline 62910 large section and is a portion of the original concrete substrate. The smaller piece is MS-10,000 fortified with Con<sup>mic</sup>Shield® and was labeled Maaline 62910 small section. See figure 8 below showing no bacterial growth from the MS-10,000 fortified with Con<sup>mic</sup>Shield®. These samples were submitted to Microbac for testing in July of 2010. See attached Microbac test report.

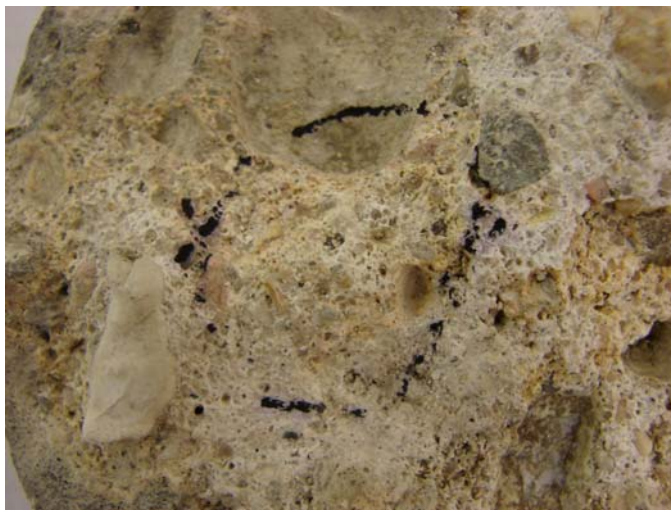
Small section

**RESULTS:** After 48 hours of incubation, sample 1 had no growth indicating the presence of ConShield. Sample 2 had some pink colonies, indicating no ConShield was present.
